**Flood Control Project Maintenance  
Levee Inspections**

**Spring 2012 Levee Inspection Results**

**Reclamation District No. 0765 Glide**

Waterway			Bank	Unit Miles
Unit No. 01 Sacramento River			Right	1.74
	Spring (March - May)	Summer (June - August)	(September - November) <b>Fall</b>	Winter (December - February)
Unit Maintenance Rating (Fall Only)				
Date of Inspection	3/13/2012 - 3/13/2012			
DWR Inspector	Richard Willoughby			
Accompanied By	Dave Chestnut RD765

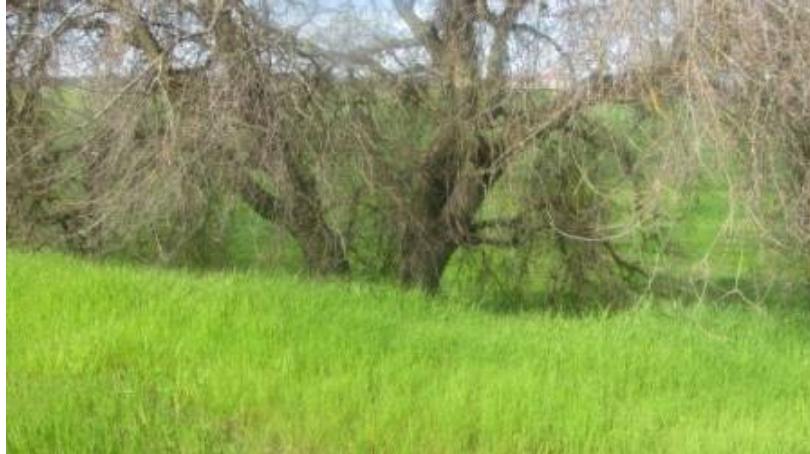
Levee Mile Report Line	8
Start Levee Mile	0.12
End Levee Mile	0.19
Location	Land Side
Category	Earthen Levee
Item	Trim / Thin Trees
Looking west at trees on landside toe.	
<a href="#">richard_s_20120313_963.jpg</a>

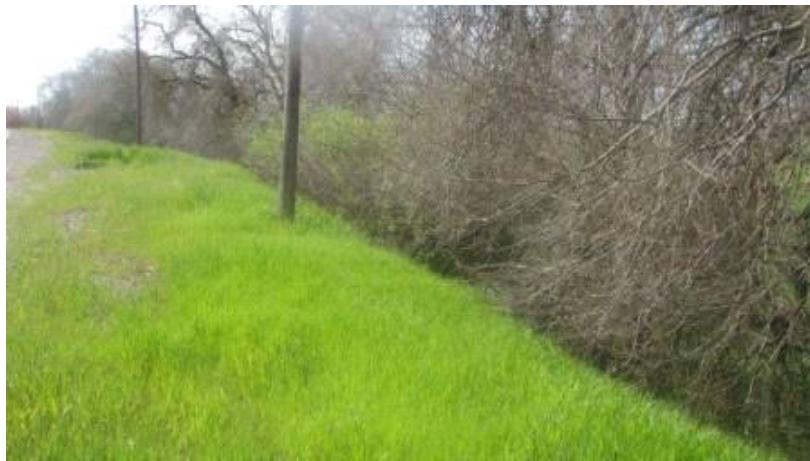
Levee Mile Report Line	8
Start Levee Mile	0.12
End Levee Mile	0.19
Location	Land Side
Category	Earthen Levee
Item	Trim / Thin Trees
Looking downstream (south) at trees on landside slope & toe.	
<a href="#">richard_s_20120313_964.jpg</a>

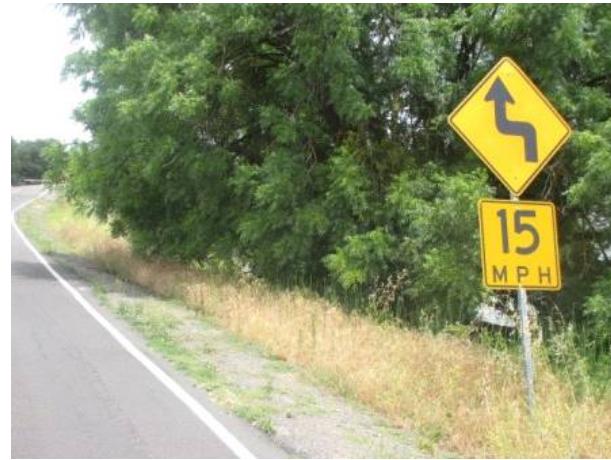
Levee Mile Report Line	12
Start Levee Mile	0.25
End Levee Mile	0.28
Location	Water Side
Category	Earthen Levee
Item	Trim / Thin Trees
Looking northeast at overgrown trees on waterside slope.	
<a href="#">richard_s_20120313_956.jpg</a>

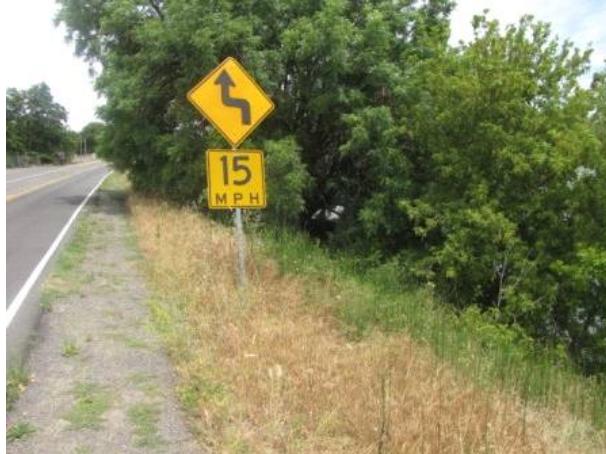
Levee Mile Report Line	12
Start Levee Mile	0.25
End Levee Mile	0.28
Location	Water Side
Category	Earthen Levee
Item	Trim / Thin Trees
Looking north at dense trees on waterside slope from fall 2010 inspection.	
richard_s_20120313_957.jpg

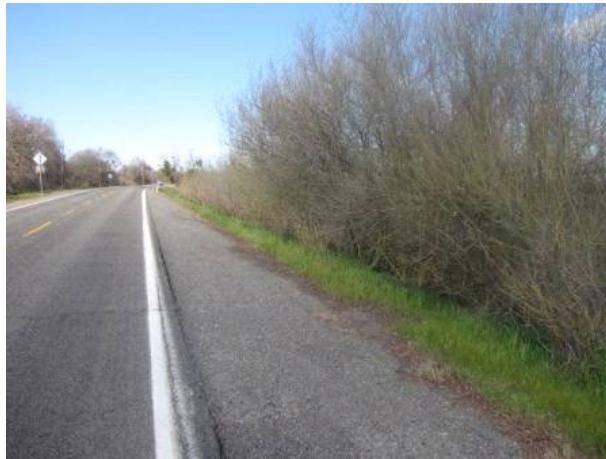
Levee Mile Report Line	12
Start Levee Mile	0.25
End Levee Mile	0.28
Location	Water Side
Category	Earthen Levee
Item	Trim / Thin Trees
Looking upstream (north) at dense vegetation and trees from 2011 spring inspection.	
richard_s_20120313_958.jpg

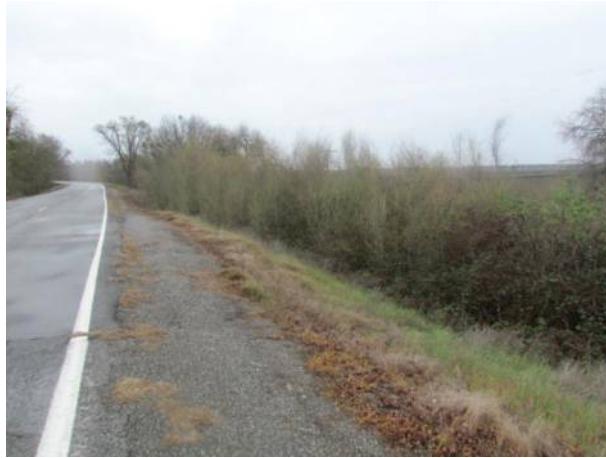
Levee Mile Report Line	16
Start Levee Mile	0.43
End Levee Mile	0.47
Location	Land Side
Category	Earthen Levee
Item	Trim / Thin Trees
Looking southwest at dense vegetation on landside slope and toe.	
richard_s_20120319_162.jpg

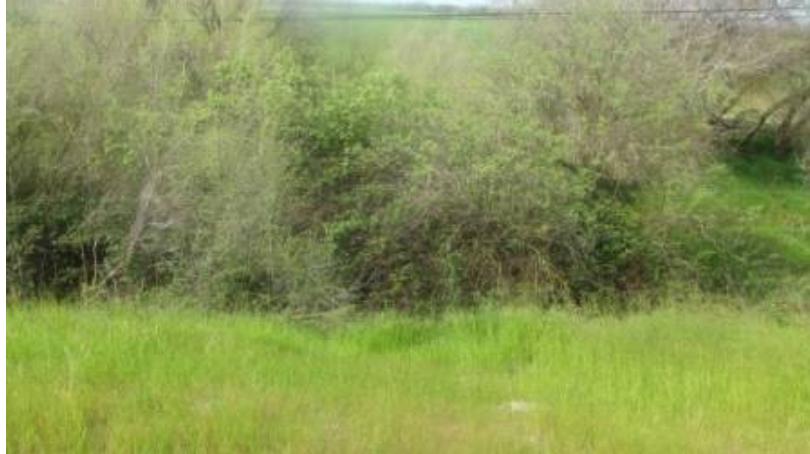
Levee Mile Report Line	17
Start Levee Mile	0.48
End Levee Mile	0.50
Location	Land Side
Category	Earthen Levee
Item	Vegetation
Looking northwest at trees on landside toe from 2010 fall inspection.	
richard_s_20120313_971.jpg

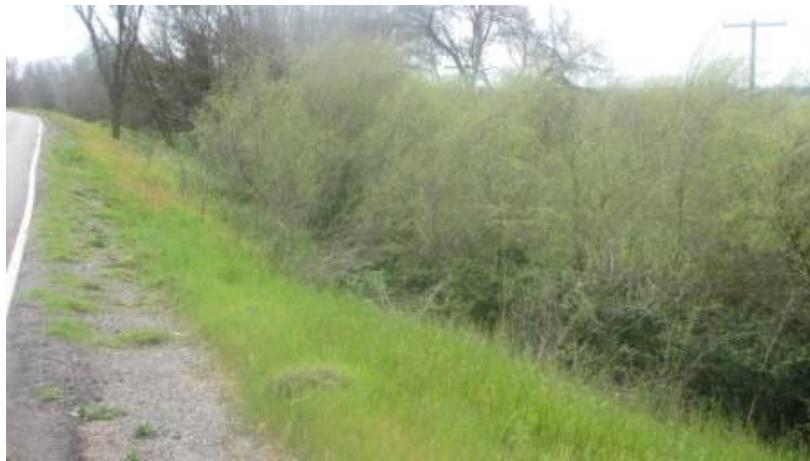
Levee Mile Report Line	17
Start Levee Mile	0.48
End Levee Mile	0.50
Location	Land Side
Category	Earthen Levee
Item	Vegetation
Looking downstream (south) at trees on landside slope & toe.	
richard_s_20120313_972.jpg

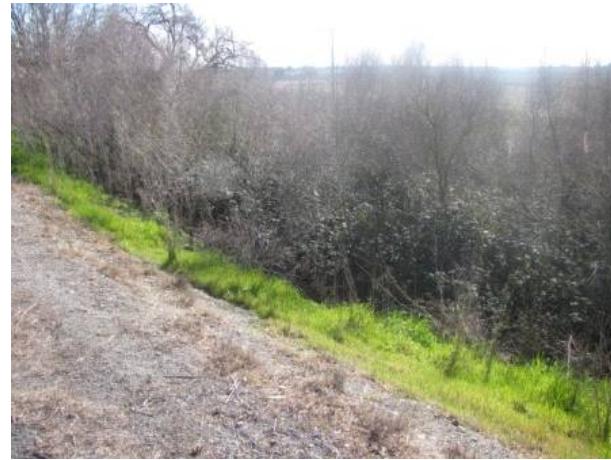
Levee Mile Report Line	17
Start Levee Mile	0.48
End Levee Mile	0.50
Location	Land Side
Category	Earthen Levee
Item	Vegetation
Looking downstream (southwest) at dense vegetation on landside slope.	
richard_s_20120313_973.jpg

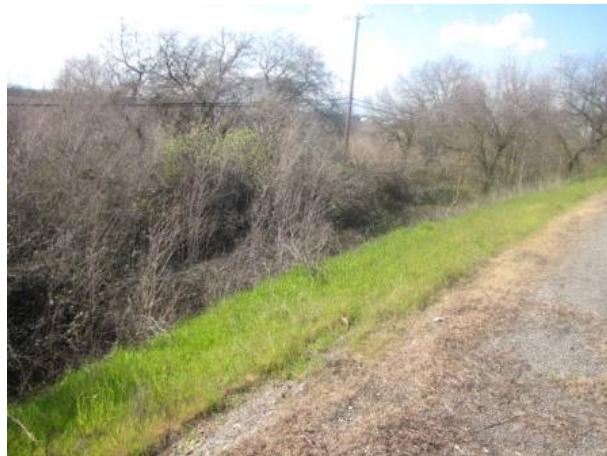
Levee Mile Report Line	17
Start Levee Mile	0.48
End Levee Mile	0.50
Location	Land Side
Category	Earthen Levee
Item	Vegetation
Looking upstream (northwest) at dense vegetation on landside slope.	
richard_s_20120313_974.jpg

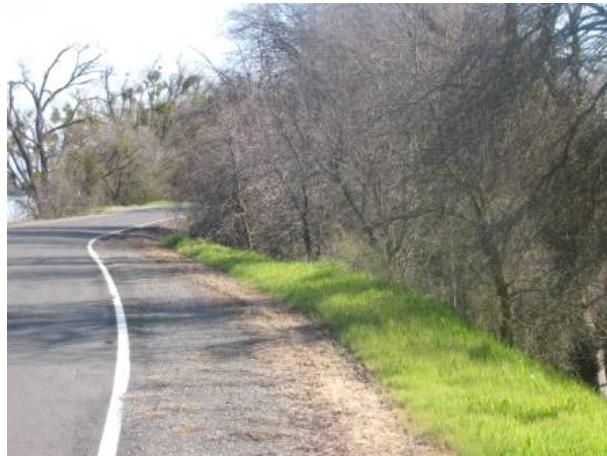
Levee Mile Report Line	26
Start Levee Mile	0.87
End Levee Mile	1.03
Location	Land Side
Category	Earthen Levee
Item	Trim / Thin Trees
Looking downstream (south) at dense trees on landside slope and toe.	
richard_s_20120313_960.jpg

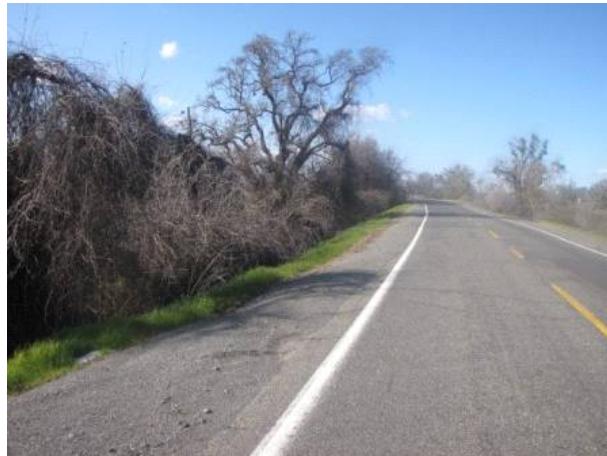
Levee Mile Report Line	26
Start Levee Mile	0.87
End Levee Mile	1.03
Location	Land Side
Category	Earthen Levee
Item	Trim / Thin Trees
Looking upstream (north) at dense trees on landside slope and toe.	
richard_s_20120313_961.jpg

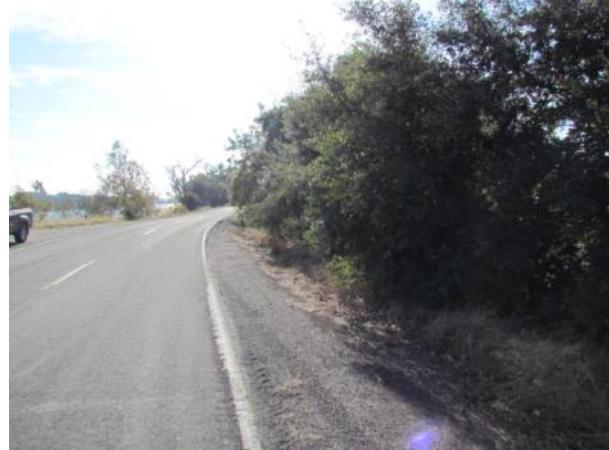
Levee Mile Report Line	26
Start Levee Mile	0.87
End Levee Mile	1.03
Location	Land Side
Category	Earthen Levee
Item	Trim / Thin Trees
Looking south at dense trees on landside shoulder and slope. (November 2011)	
richard_s_20120313_962.jpg

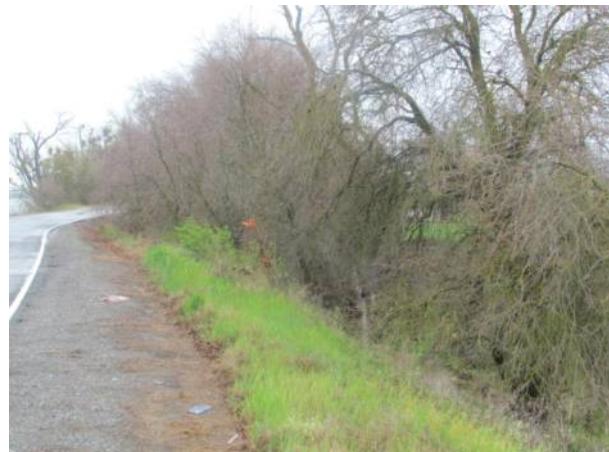
Levee Mile Report Line	26
Start Levee Mile	0.87
End Levee Mile	1.03
Location	Land Side
Category	Earthen Levee
Item	Trim / Thin Trees
Looking southwest at dense trees on landside slope and toe spring 2012	
richard_s_20120319_163.jpg

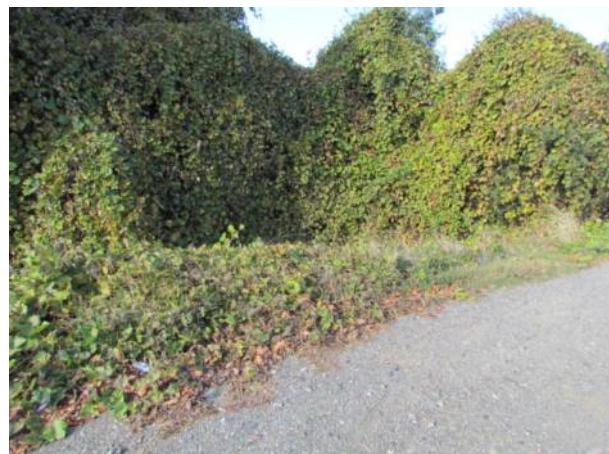
Levee Mile Report Line	27
Start Levee Mile	0.97
End Levee Mile	0.97
Location	Land Side
Category	Earthen Levee
Item	Vegetation
Looking west at dense berryvines and wildroses on landside shoulder and slope. (November 2011)	
richard_s_20120313_980.jpg

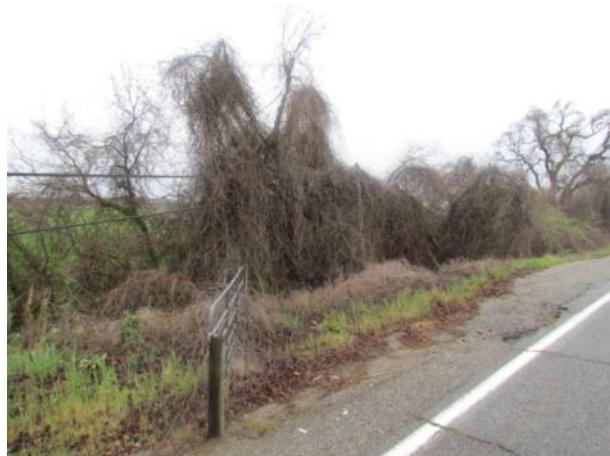
Levee Mile Report Line	27
Start Levee Mile	0.97
End Levee Mile	0.97
Location	Land Side
Category	Earthen Levee
Item	Vegetation

Looking northwest at vines on landside toe spring 2012

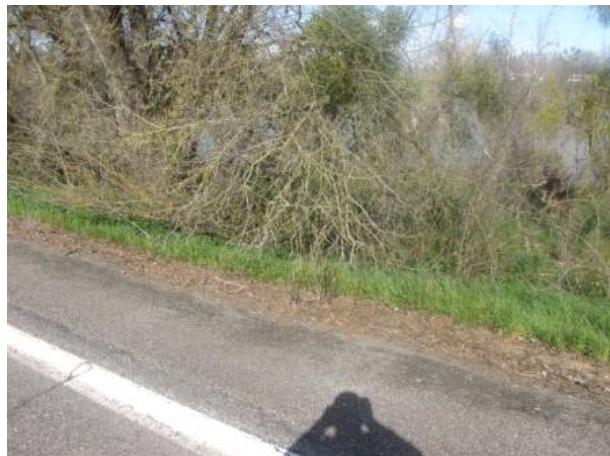
Levee Mile Report Line	28
Start Levee Mile	0.99
End Levee Mile	1.05
Location	Water Side
Category	Earthen Levee
Item	Trim / Thin Trees

Looking upstream (northeast) at dense vegetation on waterside slope.

28	0.99	1.05	Earthen Levee	Trim / Thin Trees	WS Ma	M	T2 : Thin trees to allow visibility of the ground and room to flood fight.		38.489705 ° 38.488990 ° 8 -121.555385 ° -121.554993 ° Y DWR ID: DWR_RD0765_01_s_2012_8		
29	1.02	1.02	Earthen Levee	Vegetation	LS Ma	U	V7 : Trees / Woody Vegetation		38.489283 ° 38.489283 ° 40 -121.555223 ° -121.555223 ° Y DWR ID: DWR_RD0765_01_s_2012_40

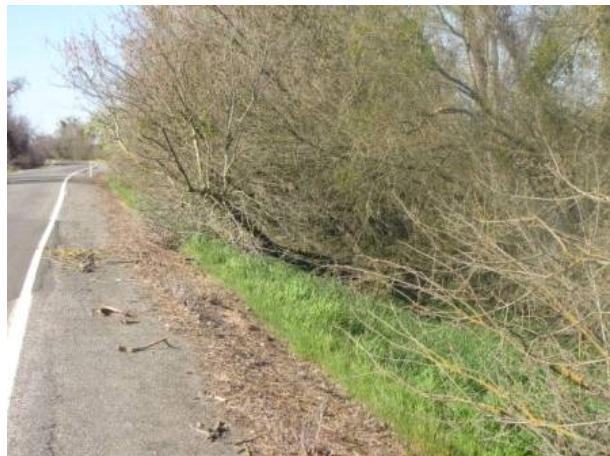
Levee Mile Report Line	28
Start Levee Mile	0.99
End Levee Mile	1.05
Location	Water Side
Category	Earthen Levee
Item	Trim / Thin Trees

Looking upstream (north) dense vegetation and trees on waterside shoulder and slope.

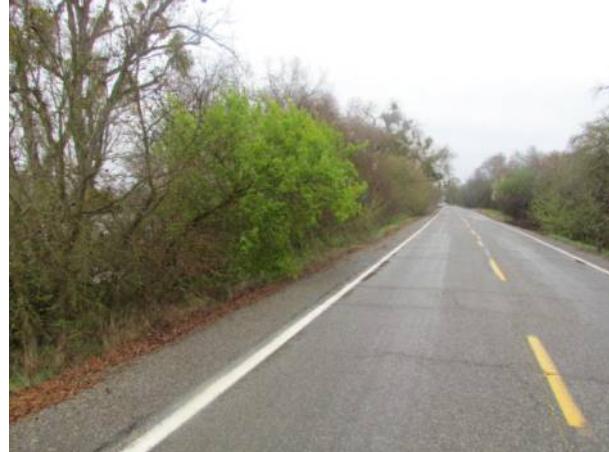
Levee Mile Report Line	28
Start Levee Mile	0.99
End Levee Mile	1.05
Location	Water Side
Category	Earthen Levee
Item	Trim / Thin Trees
Looking south at dense trees and vegetation	
richard_s_20120319_161.jpg

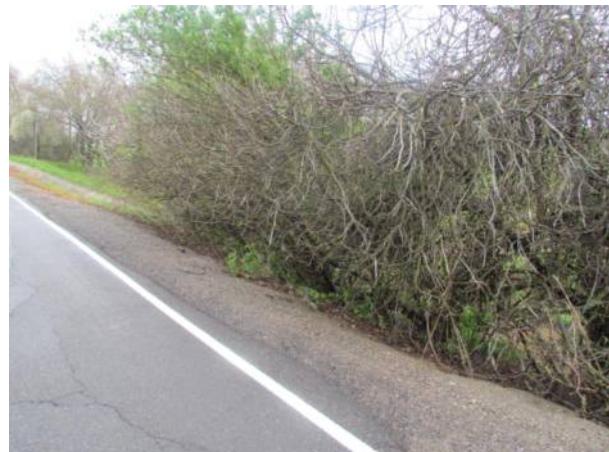
Levee Mile Report Line	29
Start Levee Mile	1.02
End Levee Mile	1.02
Location	Land Side
Category	Earthen Levee
Item	Vegetation
Looking southwest at fig trees and other trees on landside slope and toe.	
richard_s_20120319_165.jpg

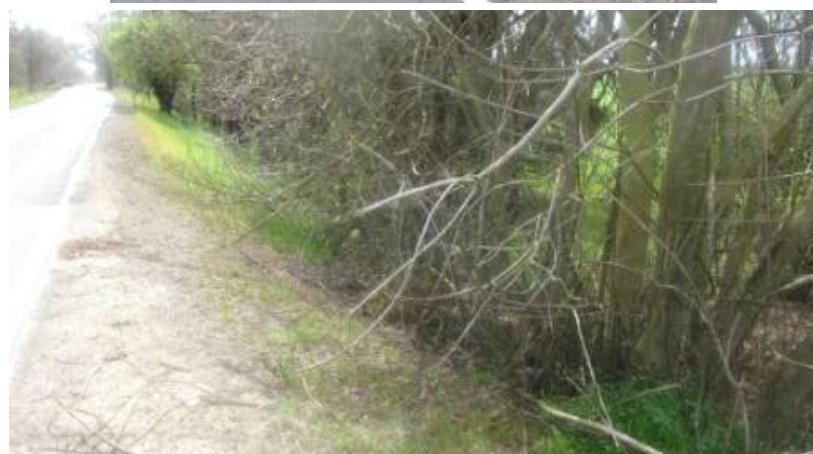
Levee Mile Report Line	30
Start Levee Mile	1.08
End Levee Mile	1.08
Location	Land Side
Category	Earthen Levee
Item	Trim / Thin Trees
Looking downstream (south) at trees on landside slope & toe from 2010 fall inspection.	
richard_s_20120313_975.jpg

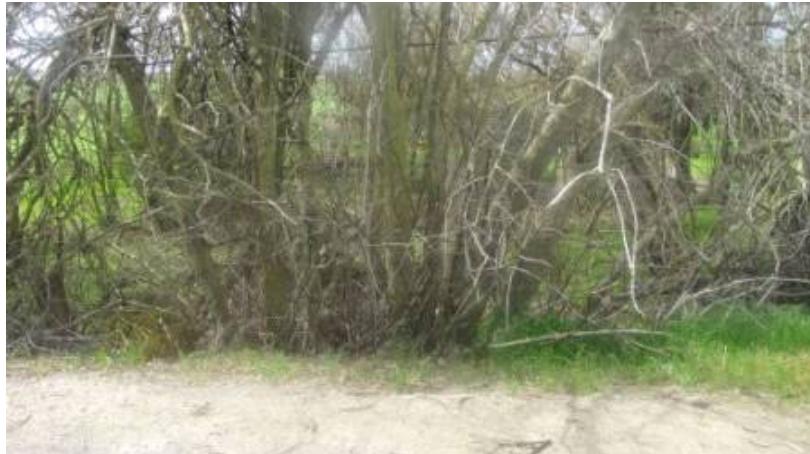
Levee Mile Report Line	30
Start Levee Mile	1.08
End Levee Mile	1.08
Location	Land Side
Category	Earthen Levee
Item	Trim / Thin Trees
Looking west at trees on landside slope & toe.	
richard_s_20120313_976.jpg

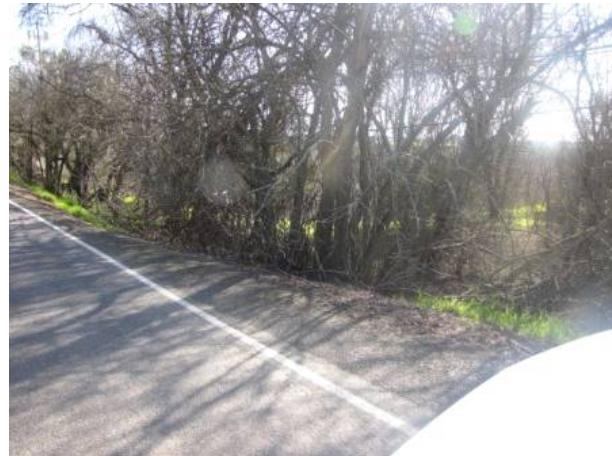
Levee Mile Report Line	30
Start Levee Mile	1.08
End Levee Mile	1.08
Location	Land Side
Category	Earthen Levee
Item	Trim / Thin Trees
Looking downstream (southwest) at dense trees on landside slope and toe.	
richard_s_20120313_977.jpg

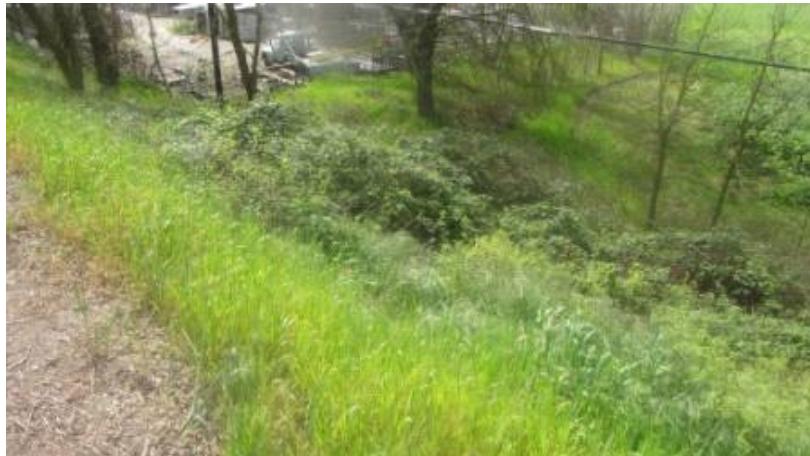
Levee Mile Report Line	32
Start Levee Mile	1.15
End Levee Mile	1.15
Location	Land Side
Category	Earthen Levee
Item	Vegetation
Looking downstream (southwest) at wild roses on landside slope & toe.	
richard_s_20120313_978.jpg

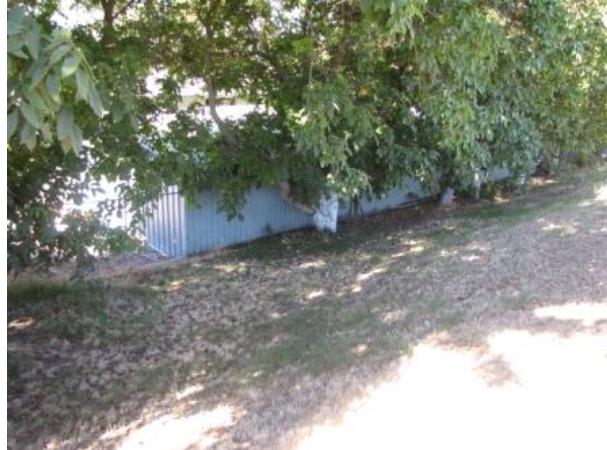
Levee Mile Report Line	34
Start Levee Mile	1.19
End Levee Mile	1.22
Location	Land Side
Category	Earthen Levee
Item	Encroachments
Looking northwest at buildings along landside toe.	
<a href="#">richard_s_20120313_979.jpg</a>

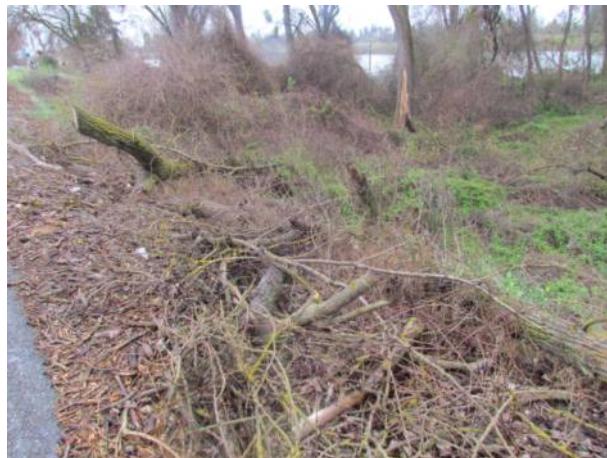
Levee Mile Report Line	36
Start Levee Mile	1.33
End Levee Mile	1.33
Location	Water Side
Category	Earthen Levee
Item	Encroachments
Looking northeast at tree limbs on waterside slope.	
<a href="#">richard_s_20120319_160.jpg</a>

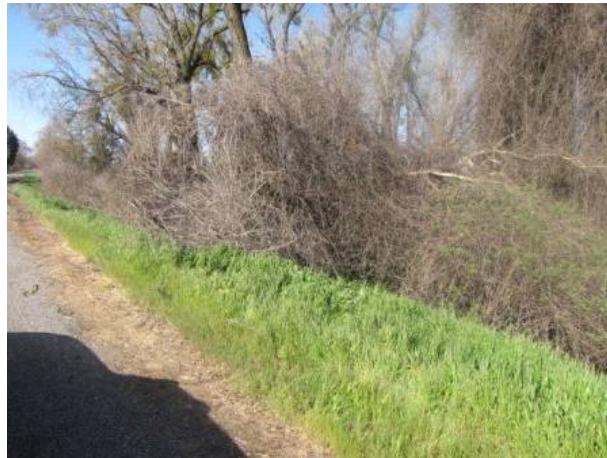
Levee Mile Report Line	37
Start Levee Mile	1.36
End Levee Mile	1.36
Location	Water Side
Category	Earthen Levee
Item	Trim / Thin Trees
Looking upstream (north) at dense vegetation on waterside slope.	
<a href="#">richard_s_20120313_953.jpg</a>

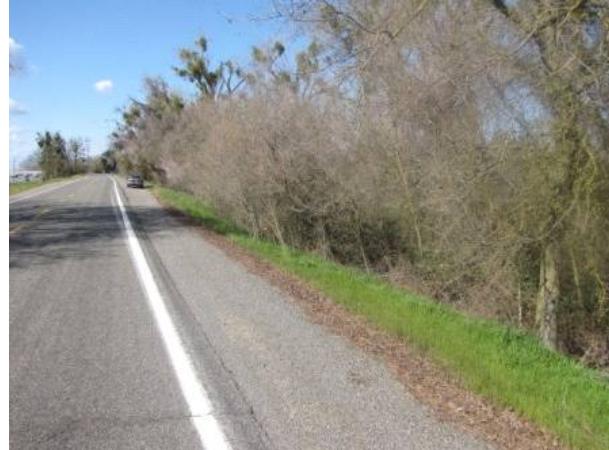
Levee Mile Report Line	39
Start Levee Mile	1.44
End Levee Mile	1.47
Location	Water Side
Category	Earthen Levee
Item	Trim / Thin Trees
Looking upstream (north) at dense trees on waterside slope.	
richard_s_20120313_952.jpg

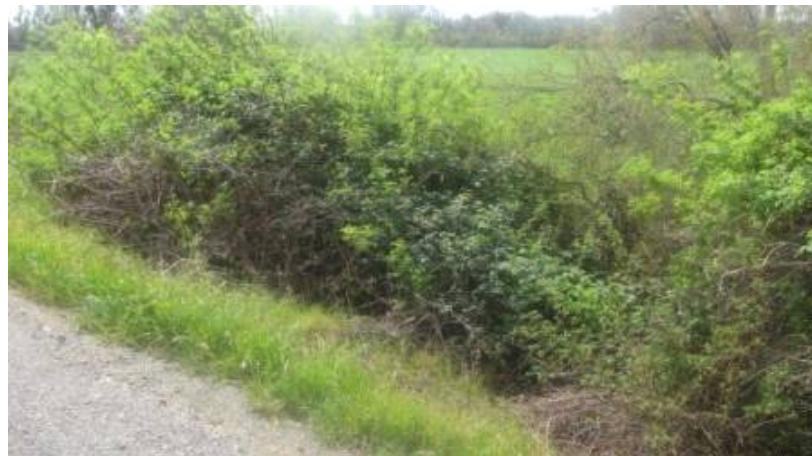
Levee Mile Report Line	42
Start Levee Mile	1.54
End Levee Mile	1.63
Location	Land Side
Category	Earthen Levee
Item	Vegetation
Looking downstream (southwest) at trees, vines & wildroses on landside slope & toe from 2010 fall inspection	
richard_s_20120313_965.jpg

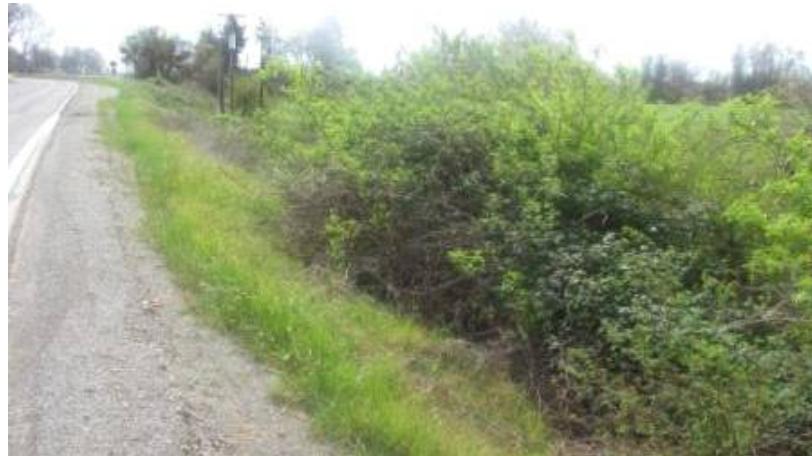
Levee Mile Report Line	42
Start Levee Mile	1.54
End Levee Mile	1.63
Location	Land Side
Category	Earthen Levee
Item	Vegetation
Looking downstream (south) at trees, vines & wildroses on landside slope & toe.	
richard_s_20120313_966.jpg

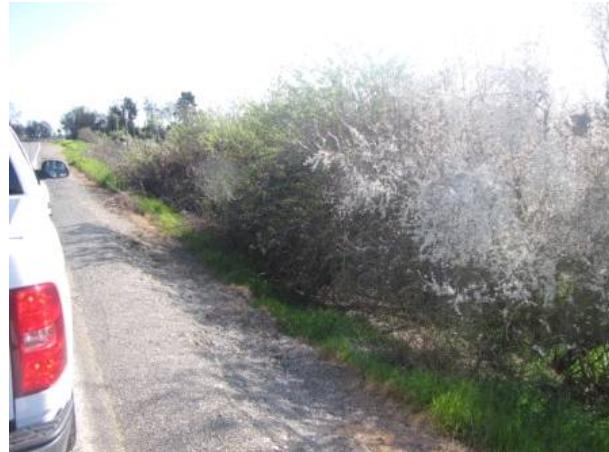
Levee Mile Report Line	42
Start Levee Mile	1.54
End Levee Mile	1.63
Location	Land Side
Category	Earthen Levee
Item	Vegetation
Looking downstream (south) at dense vegetation on landside slope and toe.	
richard_s_20120313_967.jpg

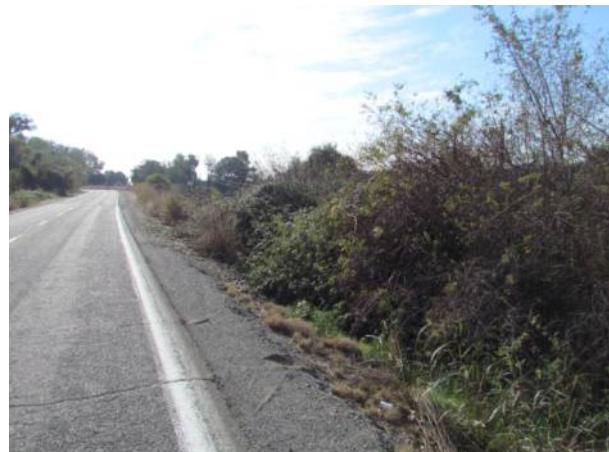
Levee Mile Report Line	42
Start Levee Mile	1.54
End Levee Mile	1.63
Location	Land Side
Category	Earthen Levee
Item	Vegetation
Looking south at dense vegetation on landside shoulder and slope. (November 2011)	
richard_s_20120313_968.jpg

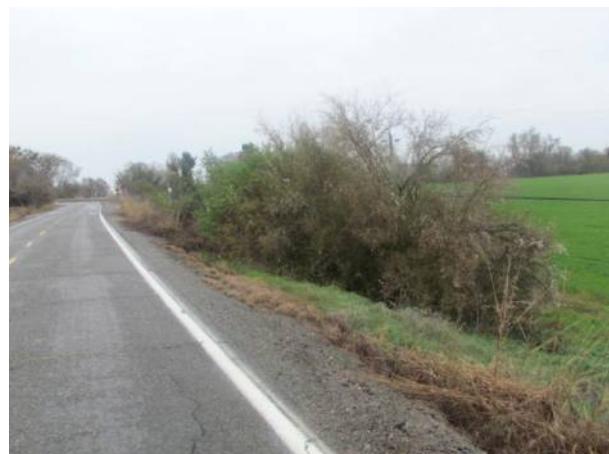
Levee Mile Report Line	42
Start Levee Mile	1.54
End Levee Mile	1.63
Location	Land Side
Category	Earthen Levee
Item	Vegetation
Looking south at dense vegetation on landside slope and toe spring 2012.	
richard_s_20120319_166.jpg

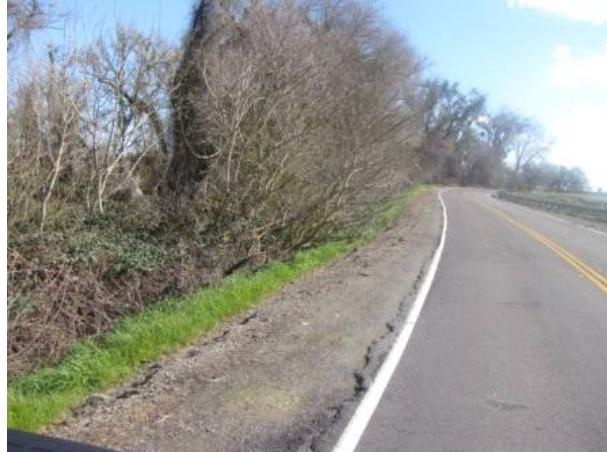
Levee Mile Report Line	43
Start Levee Mile	1.60
End Levee Mile	1.67
Location	Water Side
Category	Earthen Levee
Item	Trim / Thin Trees
Looking south at dense trees on waterside slope.	
richard_s_20120313_950.jpg

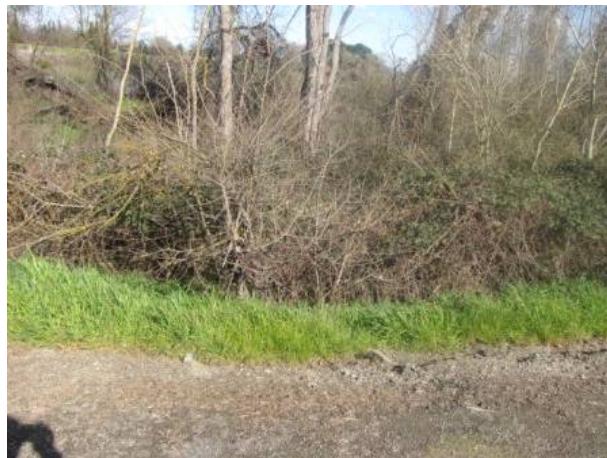
Levee Mile Report Line	43
Start Levee Mile	1.60
End Levee Mile	1.67
Location	Water Side
Category	Earthen Levee
Item	Trim / Thin Trees
Looking east at dense vegetation on waterside slope.	
richard_s_20120313_951.jpg

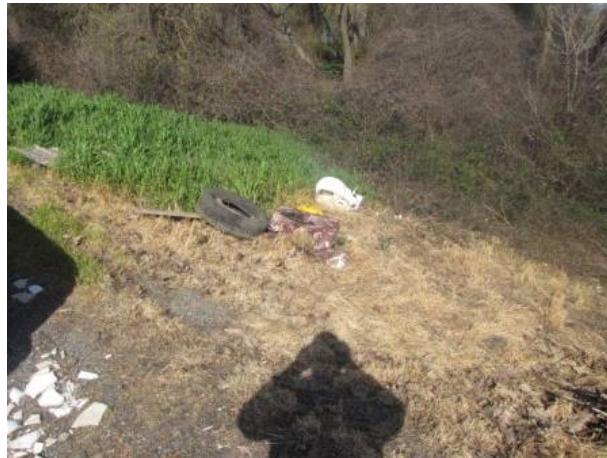
Levee Mile Report Line	45
Start Levee Mile	1.69
End Levee Mile	1.69
Location	Water Side
Category	Earthen Levee
Item	Encroachments
Looking northeast at garbage on waterside slope. (May 2011)	
richard_s_20120313_969.jpg

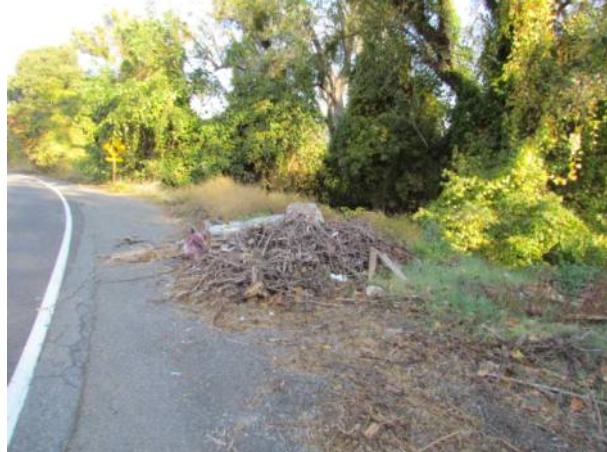
Levee Mile Report Line	45
Start Levee Mile	1.69
End Levee Mile	1.69
Location	Water Side
Category	Earthen Levee
Item	Encroachments
Looking north at garbage and pruning pile on waterside shoulder. (November 2011)	
richard_s_20120313_970.jpg

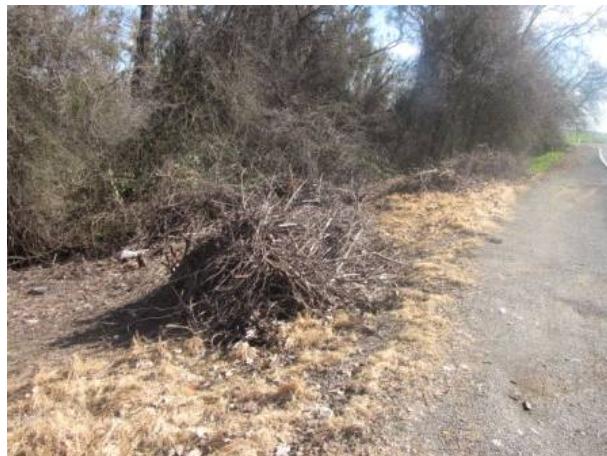
Levee Mile Report Line	46
Start Levee Mile	1.70
End Levee Mile	1.70
Location	Water Side
Category	Earthen Levee
Item	Encroachments
Looking southeast at pruning piles on waterside shoulder & slope.	
richard_s_20120313_959.jpg

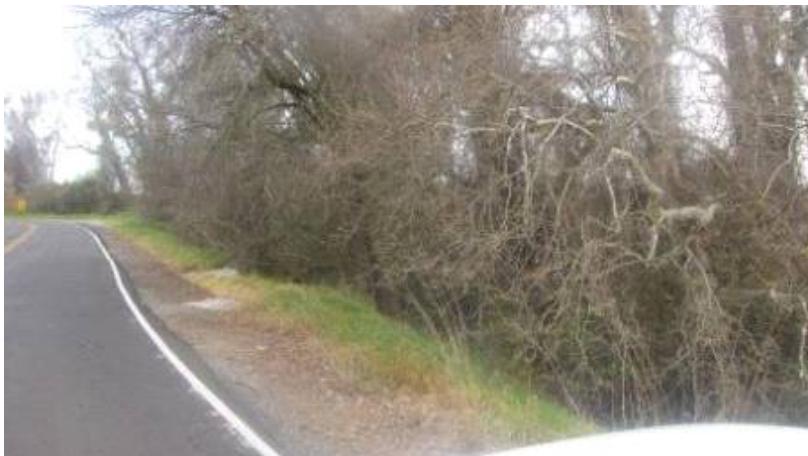
Levee Mile Report Line	47
Start Levee Mile	1.70
End Levee Mile	1.73
Location	Water Side
Category	Earthen Levee
Item	Trim / Thin Trees
Looking upstream (north) at trees on waterside slope.	
richard_s_20120313_947.jpg

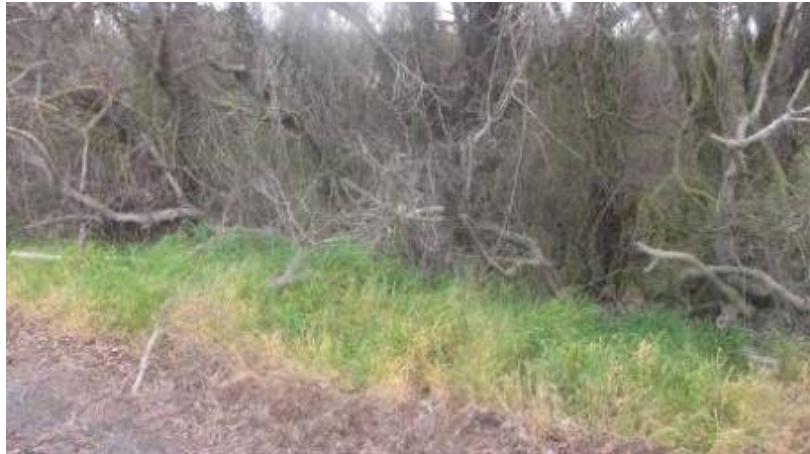
Levee Mile Report Line	47
Start Levee Mile	1.70
End Levee Mile	1.73
Location	Water Side
Category	Earthen Levee
Item	Trim / Thin Trees
Looking east at trees on waterside slope.	
richard_s_20120313_948.jpg

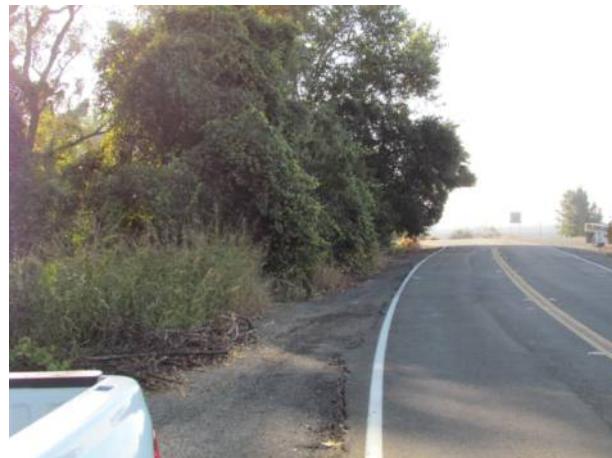
Levee Mile Report Line	47
Start Levee Mile	1.70
End Levee Mile	1.73
Location	Water Side
Category	Earthen Levee
Item	Trim / Thin Trees
Looking south at dense trees and vegetation on waterside slope. (November 2011)	
richard_s_20120313_949.jpg
